***GROUND IMPROVEMENT***  
**PROJECT TRACK RECORDS**

Version 2.0

2017

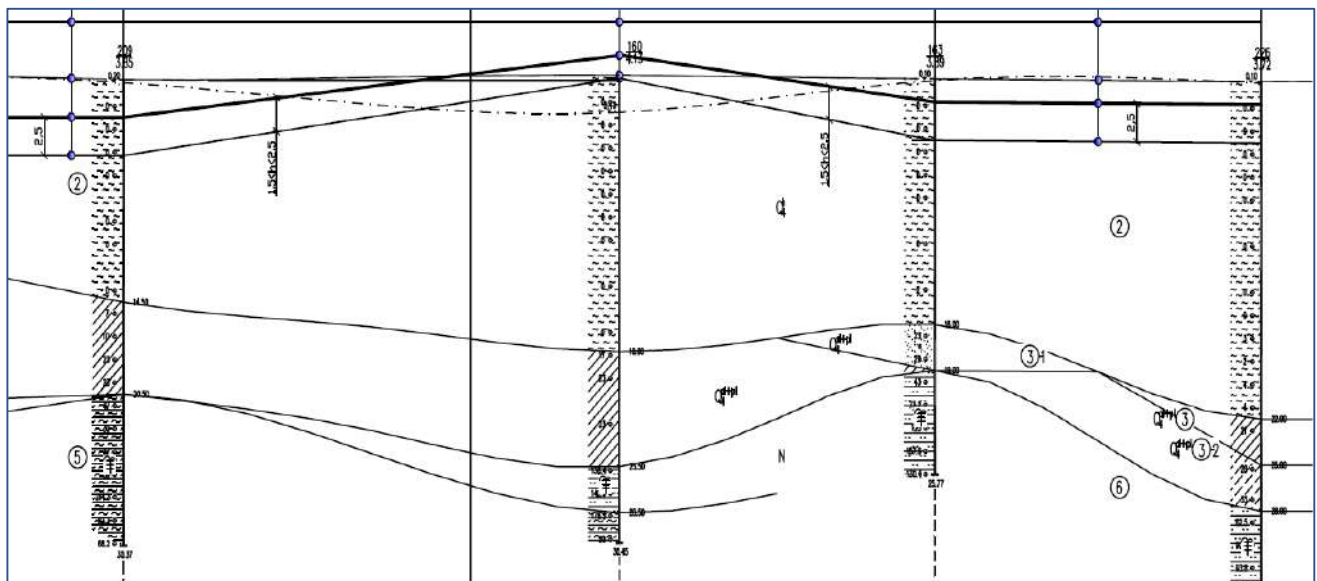
Figure 1.4.a Typical Soil Profile

- ❖ LAYER 1 PEAT: The thickness of peat layer varied between 3~4.2 m in most areas.

- ❖ LAYER 2 SILT: Dark brown, very wet, soft and plastic with high liquidity index ( $I_L > 0.75$ ), mixed with vegetation and altered to peat locally.

- ❖ LAYER 3 CLAY: Greyish Brown, stiff and plastic ( $0 < I_L \leq 0.25$ ), very wet, slightly mixed with fine sands, silts and gravels.
- ❖ LAYER 3-1 SAND: Greyish Brown, saturated, mostly medium dense ( $15 < N \leq 30$ ) and partially slightly dense ( $10 < N \leq 15$ ), mixed with clayey soils, silts and gravels.
- ❖ LAYER 3-2 SILT: Greyish Black, very wet, mostly medium dense ( $15 < N \leq 30$ ), mixed with clayey soils and fine sands.

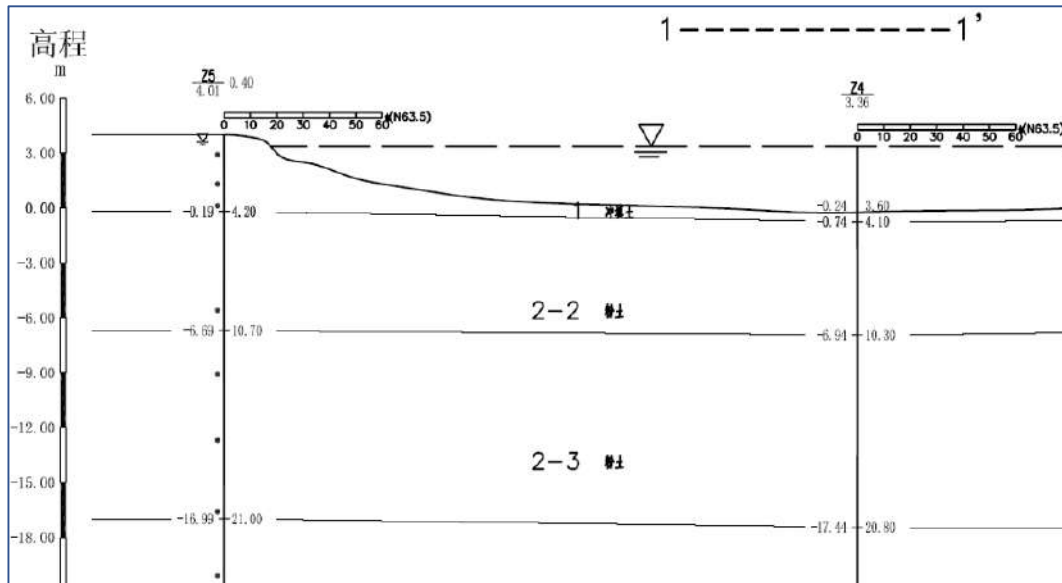
Figure 2.1.a Typical Soil Profile

- ❖ LAYER 1: RECLAIMED FILL, which mainly consisted of pale yellow and grey silts (fluid and plastic), but also contained a relatively large amount of clays (16.5 % in average). This layer was under-consolidated, and the thickness varied between 2.2 and 7m
- ❖ LAYER 2: SILTY, with thickness of 15~17 m, and could be subdivided into:
  - LAYER 2-1 SATURATED SILT with high amount of clays, with medium compressibility
  - LAYER 2-2 SATURATED GRAY SILT with small amount of silty sands, with low to medium compressibility
  - LAYER 2-3 SATURATED SILT (yellow green to yellow-grey), medium dense and with low to medium compressibility
  - LAYER 3 MUDDY SILTY CLAY (grey), fluid and plastic, with high compressibility
  - LAYER 4 SILTY CLAY (grey) with high plasticity, plenty of silts, small amount of organic substances and some shell debris, with medium to high compressibility

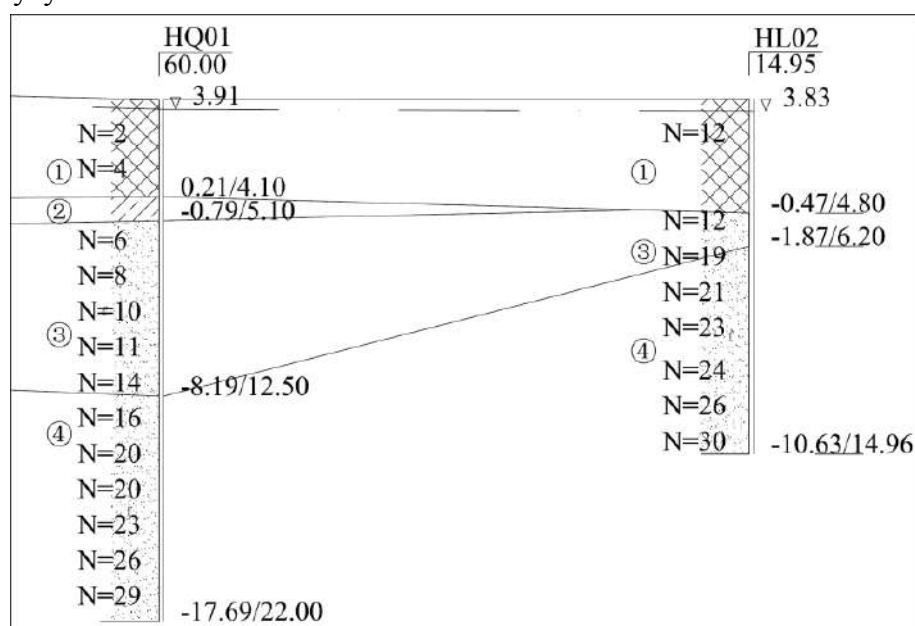
Figure 2.3.a Typical Soil Profile with SPT N-number

The topsoil on the site mainly consists of reclaimed silt sands, silts and silty clays. The soils are characterised by loose structure, high water content, low bearing capacity, and high clayey contents.

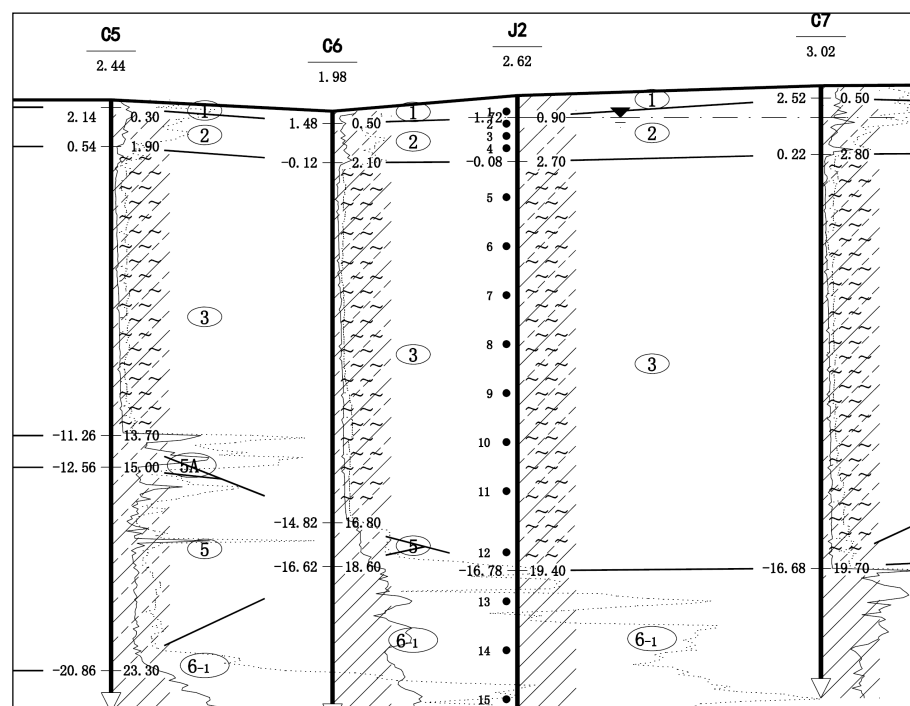
Figure 3.2.a Typical Soil Profile

- ❖ LAYER 1: FILL, with loose and inhomogeneous structure, 0.30~3.19 m thick
- ❖ LAYER 2: SILTY CLAY (greyish yellow to grey), soft and plastic, with medium compressibility, 0.70~3.60 m thick
- ❖ LAYER 3: SILTY CLAY (grey), fluid and plastic, 1.50~21.20 m thick
- ❖ LAYER 4-1: SILTY CLAY (greyish yellow), stiff and plastic, and with medium compressibility, 1.80~5.60 m thick

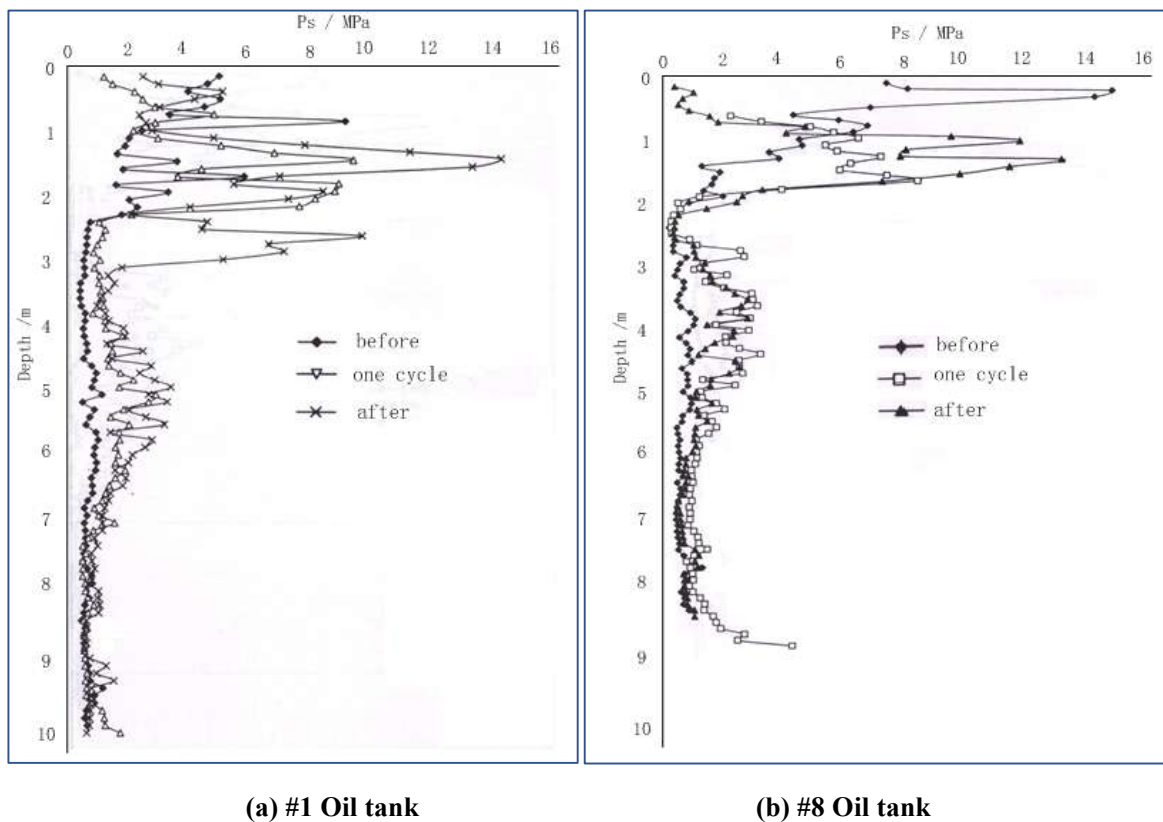
Figure 3.5.d CPT Cone Resistance Results before, during and after Ground Improvement

Bearing Capacity was increased from original 40~50 kPa to 120 kPa by HVDM, and further increased to 210 kPa by Stone Columns.

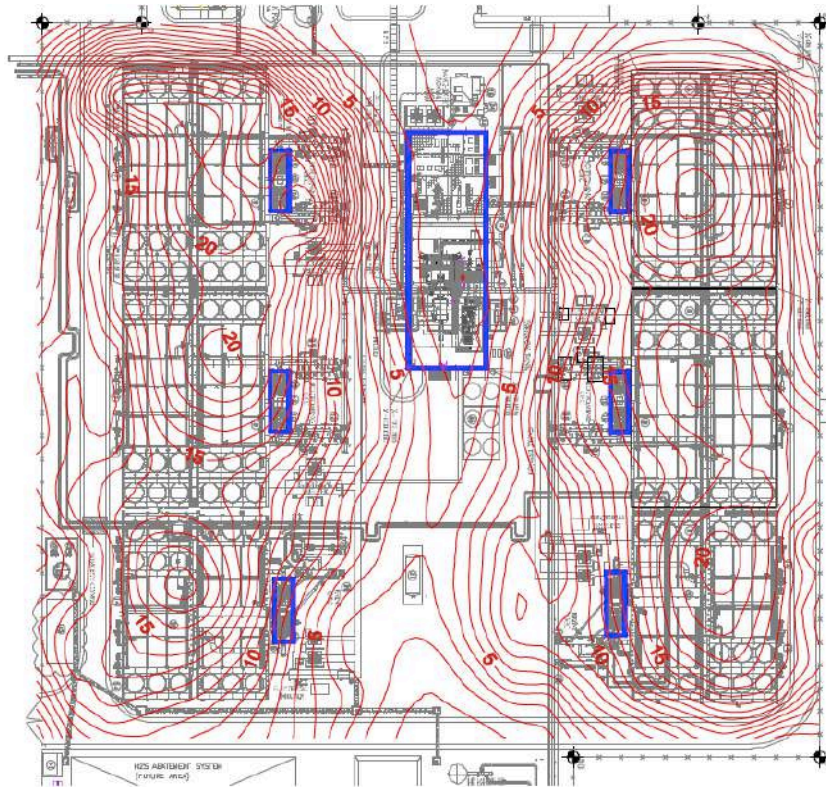
**Figure 5.1.g Settlement Contour of the Full model**

From the settlement results shown in Fig. 5.1.g, it is observed the maximum settlement was less than 25 mm which met the design requirement. Figure 5.1.f shows the cross section of the largest differential settlement, and it is observed the maximum differential settlement is 1/858, which is less than design requirement 1/300.

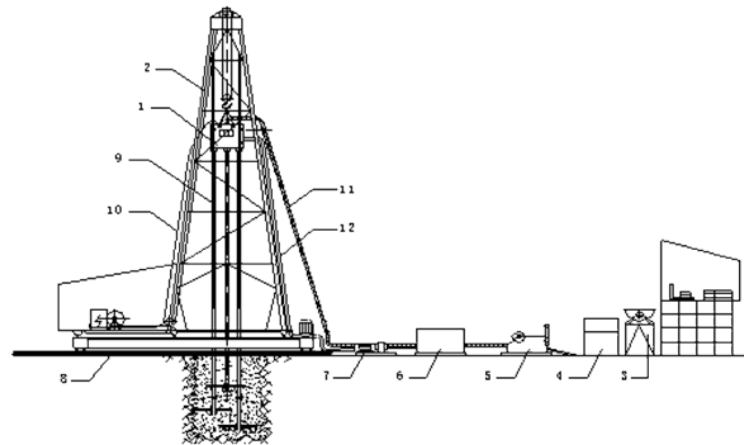
**Figure 5.1.i DCM equipment**

Figures 5.1.i and 5.1.j schematically show the DCM equipment and construction sequences, respectively.

1- host ; 2 - rack ; 3- mortar mixing machine ; 4- hopper ; 5- mortar pump ; 6- storage tank ; 7- cooling water pump ; 8- rail ; 9- guide tube ; 10- cable ; 11- loose slurry pipe ; 12- pipes

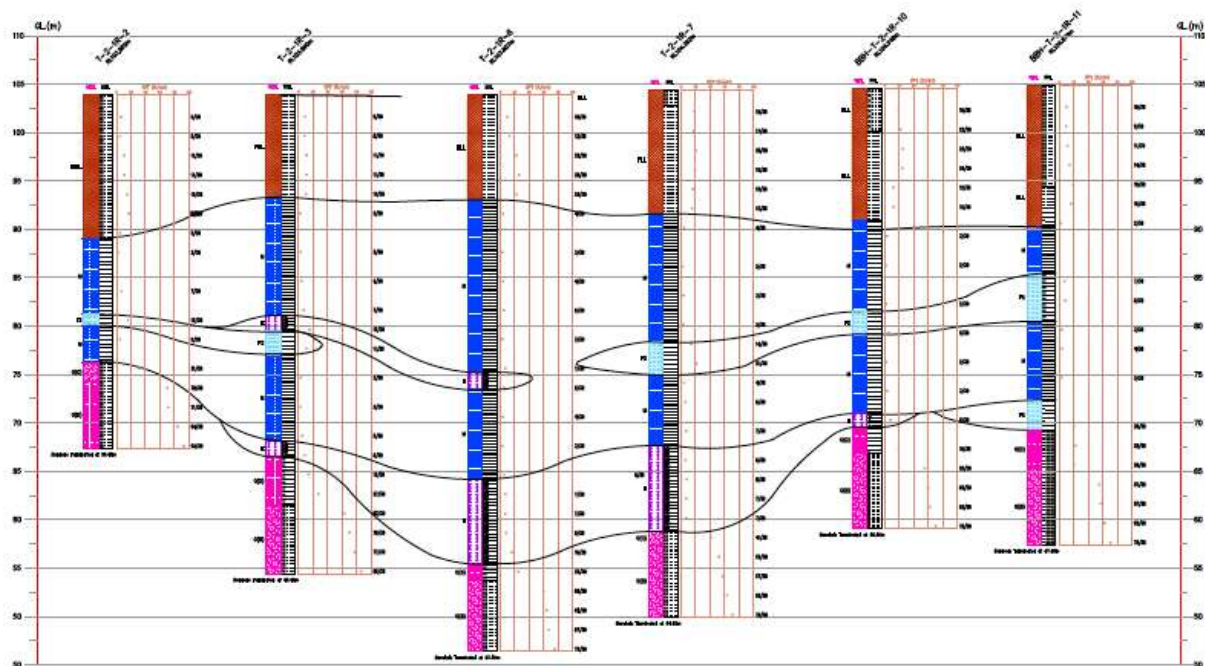
Figure 5.2.a Soil Profile at a Cross Section

Figures 5.2.a and 5.2.b show the soil profile and CPT results, which indicated that there was a very thick (about 10 m) sand layer crust at the group surface. A deep soil mixing work was required for a deep impermeable slurry wall because the shallow slurry trench cannot reach to the depth of the clay layer.

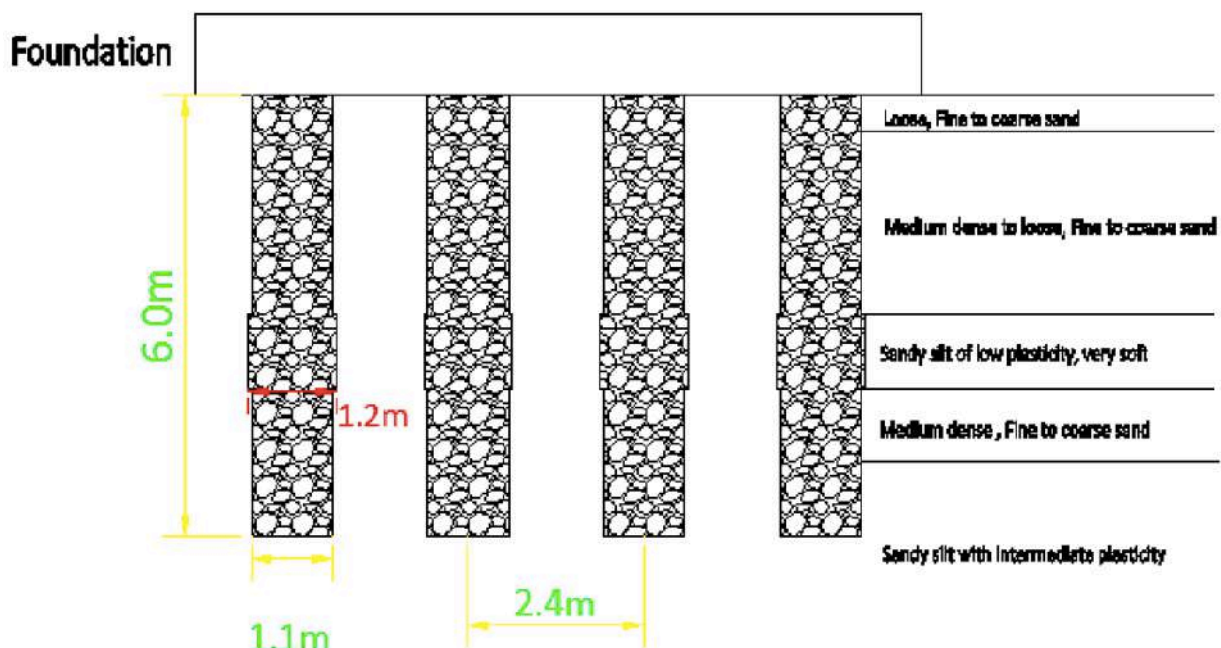
Figure 6.1.a Typical Stone Column Profile

Typical profile of stone columns is shown in Fig. 6.1.a, which also indicates the soil profile comprises of: (1) Loose, fine to coarse sand; (2) Medium dense to loose, fine to coarse sand; (3) Sandy silt of low plasticity, very soft; (4) Medium dense, fine to coarse sand; and (5) Sandy silt with intermediate plasticity. Layout of all columns is given in Fig. 6.1.b.

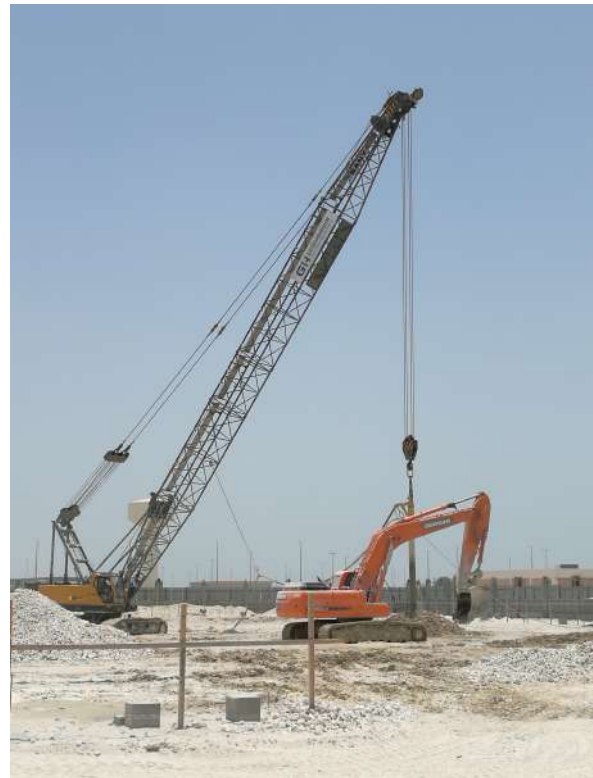
Figure 6.1.c Vibro-replacement work in Bahrain: (a) Vibro, (b) Stone column

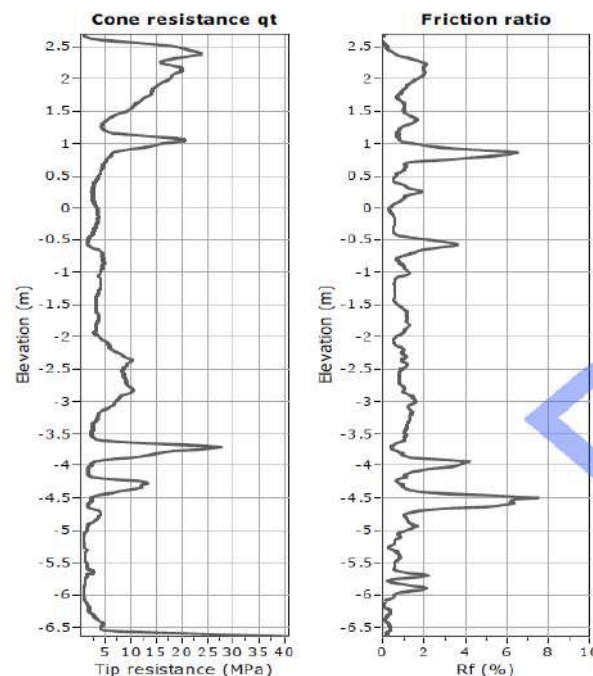
**Figure 6.2.a Pre-treatment CPT test results**

The backfilled soils above rock layer was compressible layer. Average depth of rock layer is 9 m, and the final average excavation level was 2.1 m. Therefore, the compressible layer thickness was considered as 6.9 m. Below the compressible layer, there underlie the sandstone and siltstone layers. The CPT test results for the top soils are shown in Fig. 6.2.a.

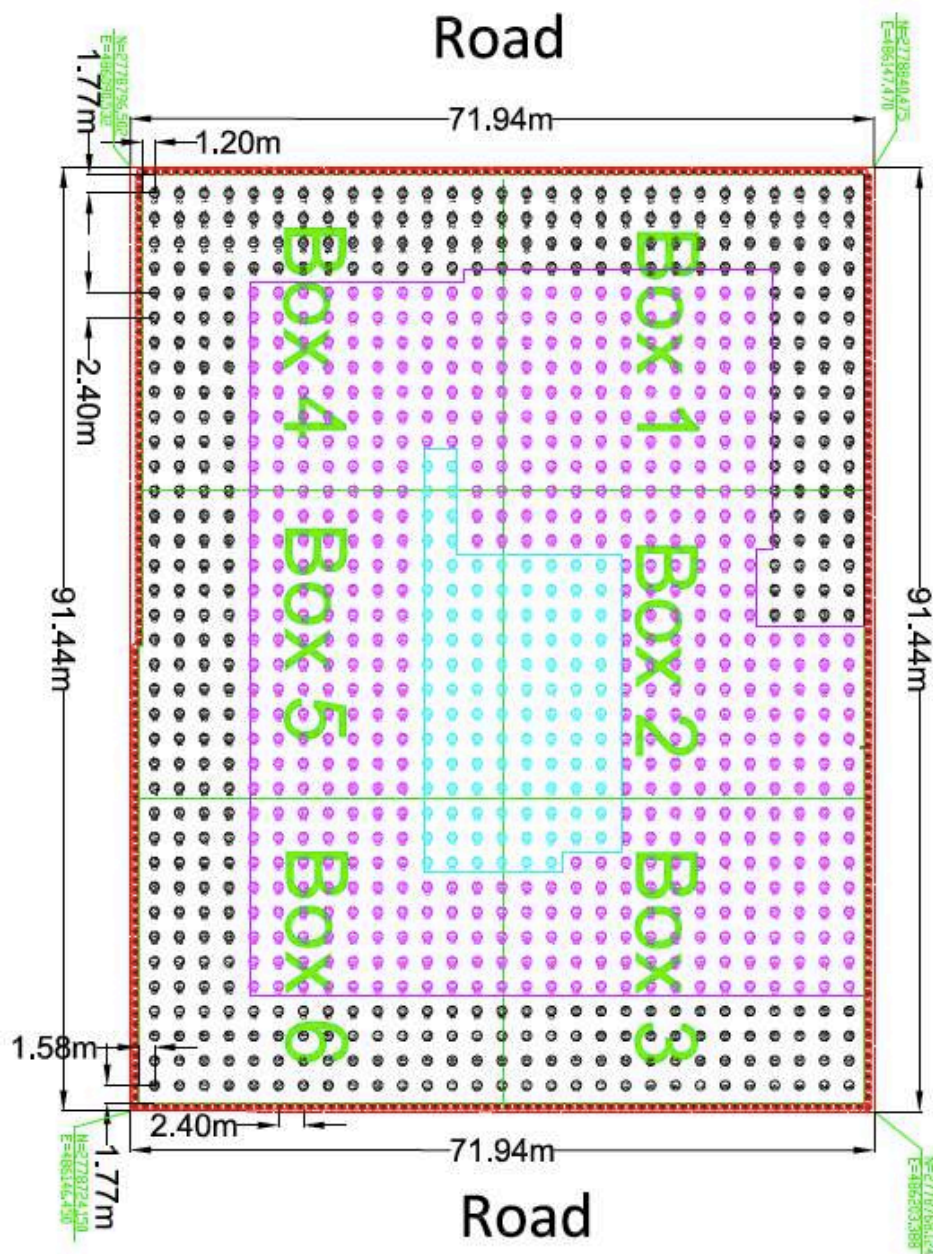
Figure 6.2.b Layout of Stone Columns

- Stone column length: 6.9 m
- Stone diameter: 0.9 m
- $E_s$  of soils: 18 MPa
- Grid spacing in rectangular pattern: 2.4 m
- Footing size: 70.3 m by 89.9 m
